Navajo Abandoned Uranium Mine

Site Screen Report

Black Rock Point Mines AUM Site

August 2010

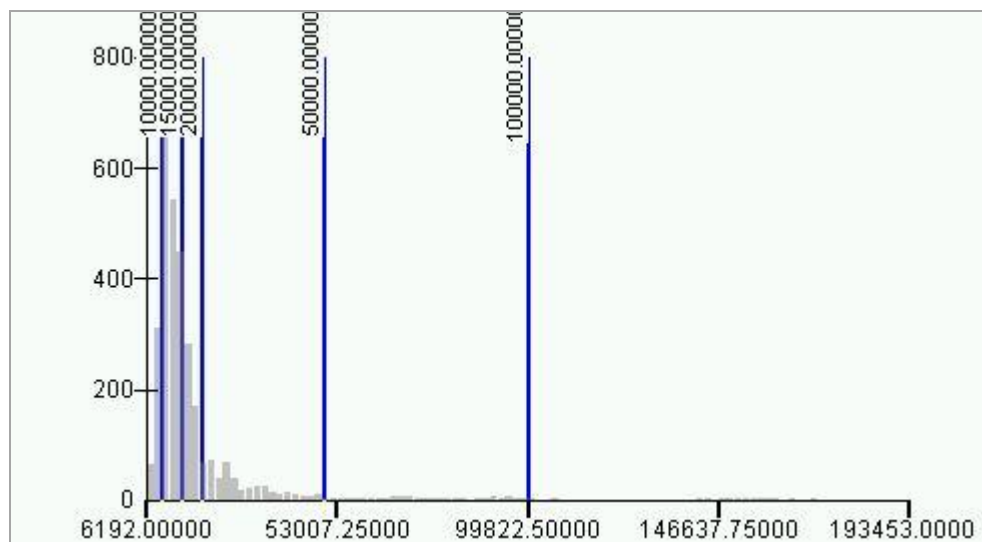
The following chart and statistics were generated by ESRI ArcGIS 9.3.1, and show the general distribution of the site gamma radiation measurements. The horizontal X axis represents the gamma radiation reading levels in cpm (lowest levels to the left). The vertical Y axis represents the frequency of each gamma radiation level.

Count:	3090
Minimum:	6192.00000
Maximum:	193453.00000
Sum:	60087187.00000
Mean:	19445.69159
Median:	13545.50000
Standard Deviation:	21165.95822

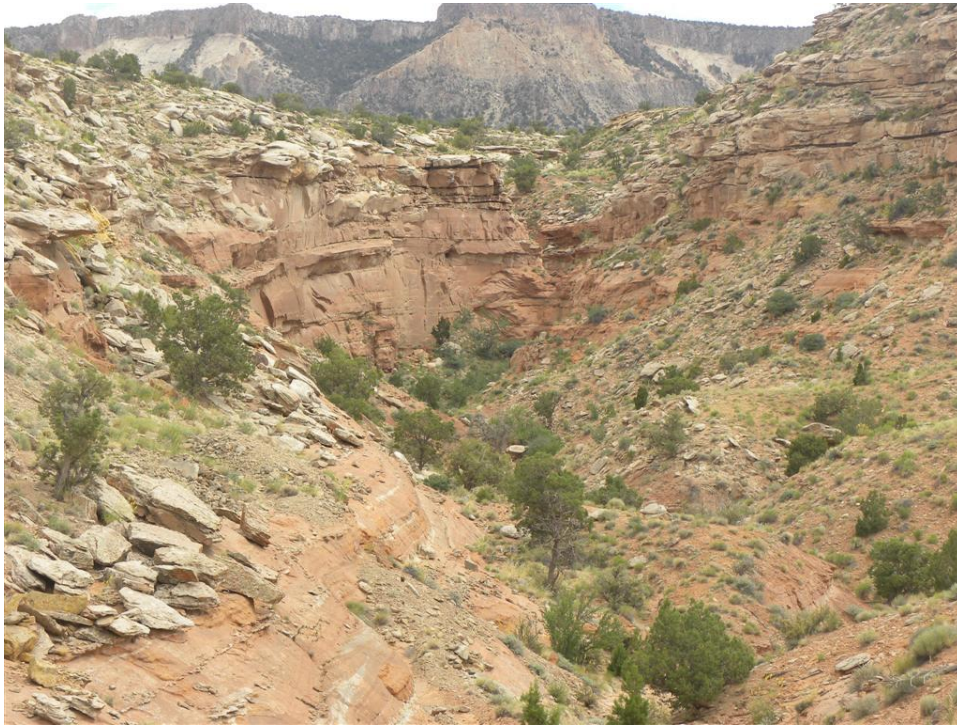
Photo 1. Black Rock Point Mines, western (Owl Canyon) area

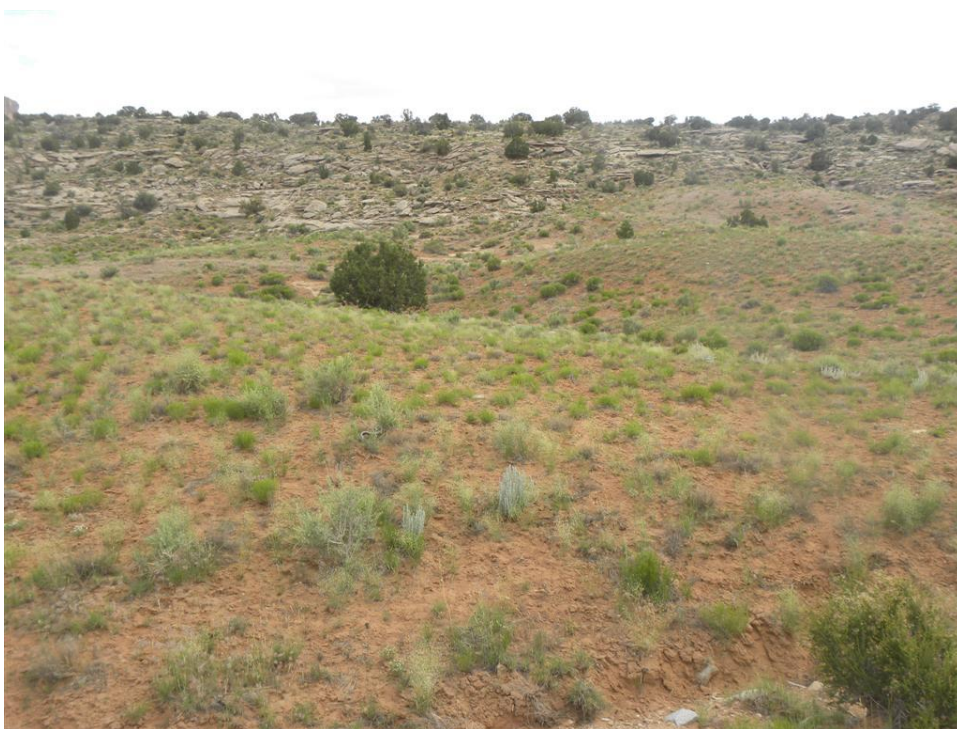
Photo 2. Black Rock Point Mines, eastern open area

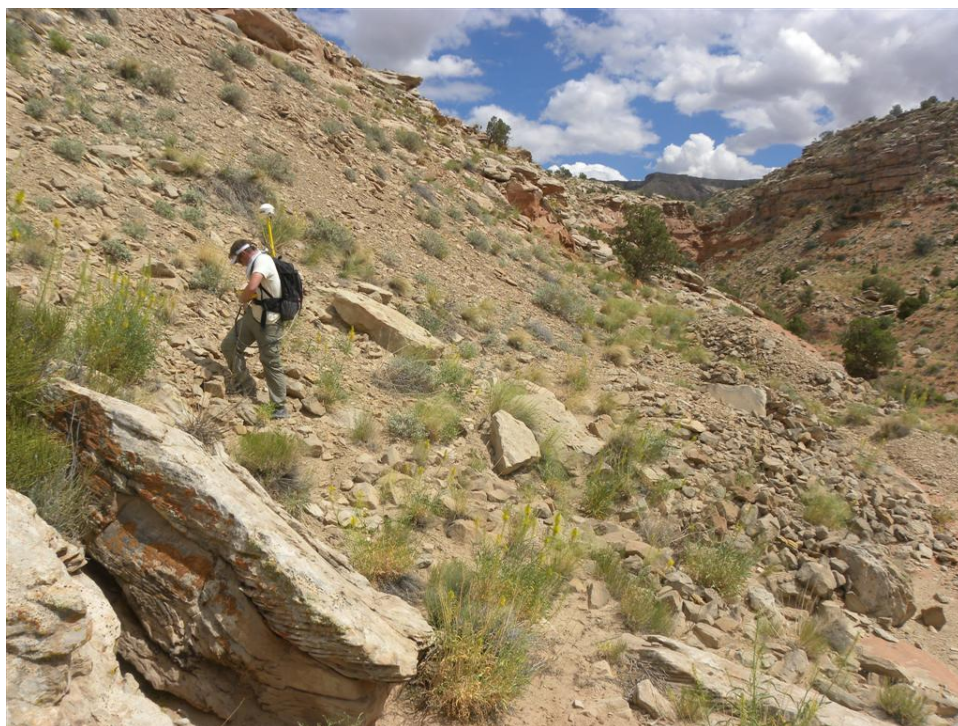
Photo 3. Black Rock Point Mines, slope

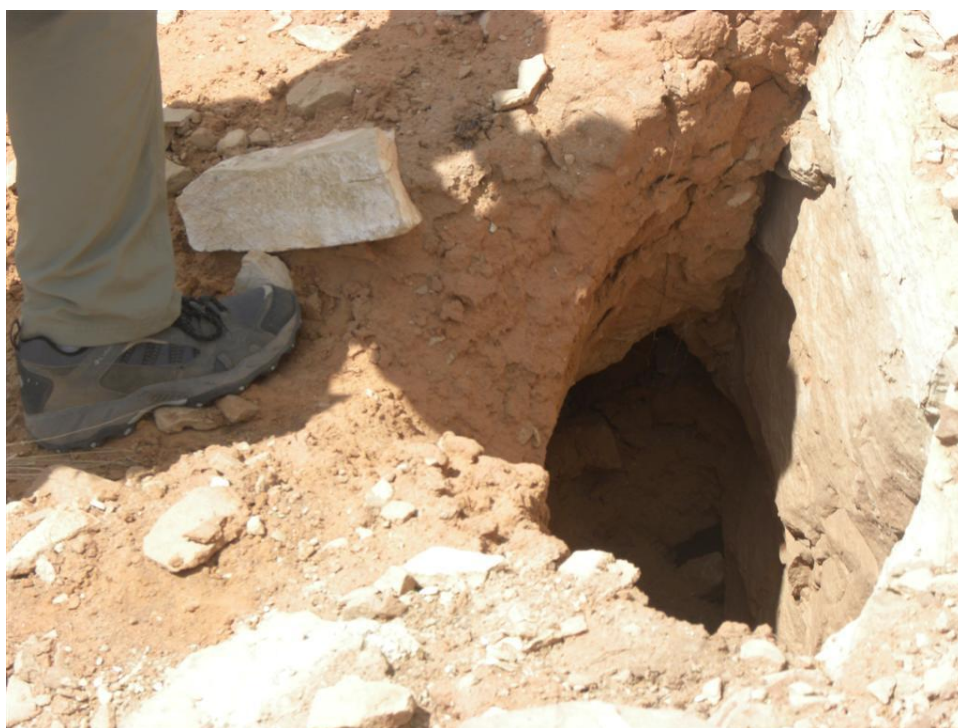
4' x 3' hole, local resident claimed it was actually a dirt covered steel-sealed adit

Photo 4. Black Rock Point Mines, hole above buried adit

Sealed/buried adit; unreclaimed waste rock

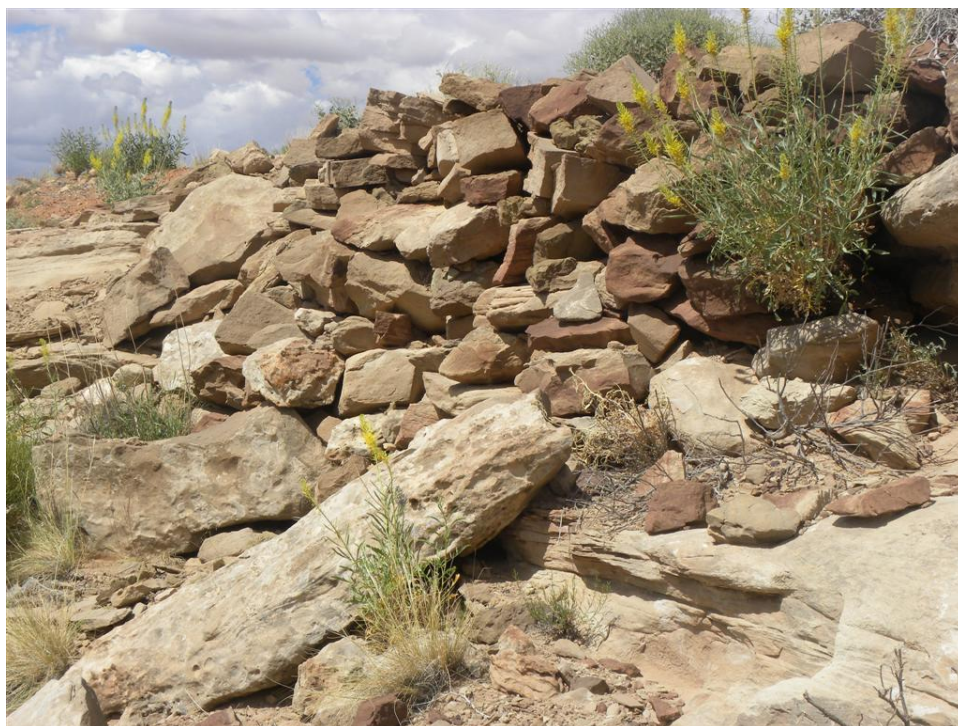
Photo 5. Black Rock Point Mines, rock with elevated gamma readings

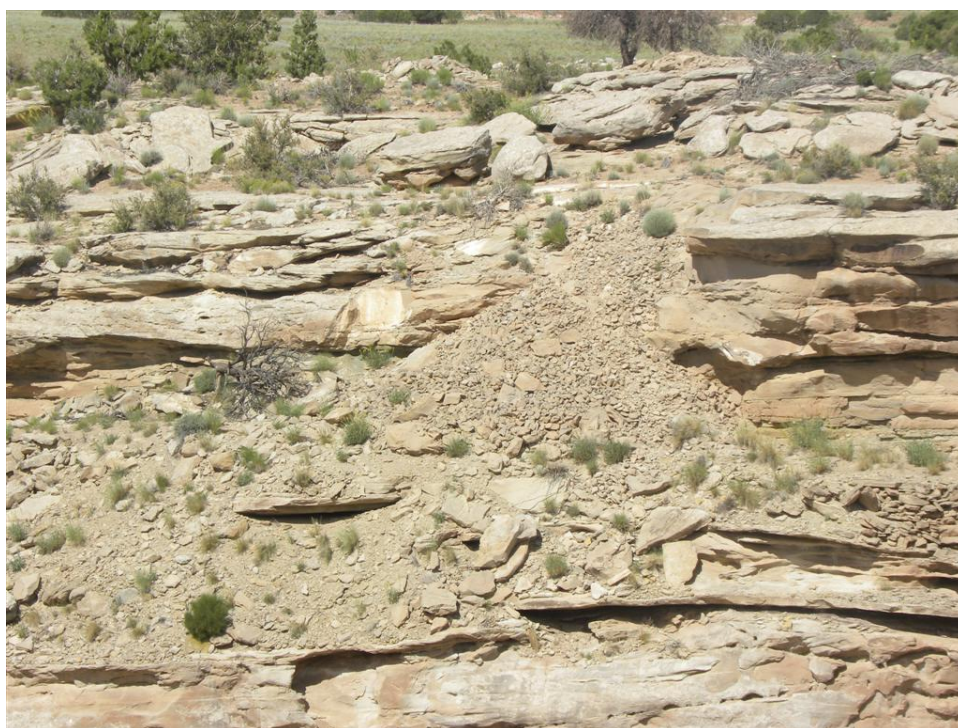
200' x 75' x 5' down-hill below hole area; additional rock scattered throughout site

Photo 6. Black Rock Point Mines, waste rock down slope

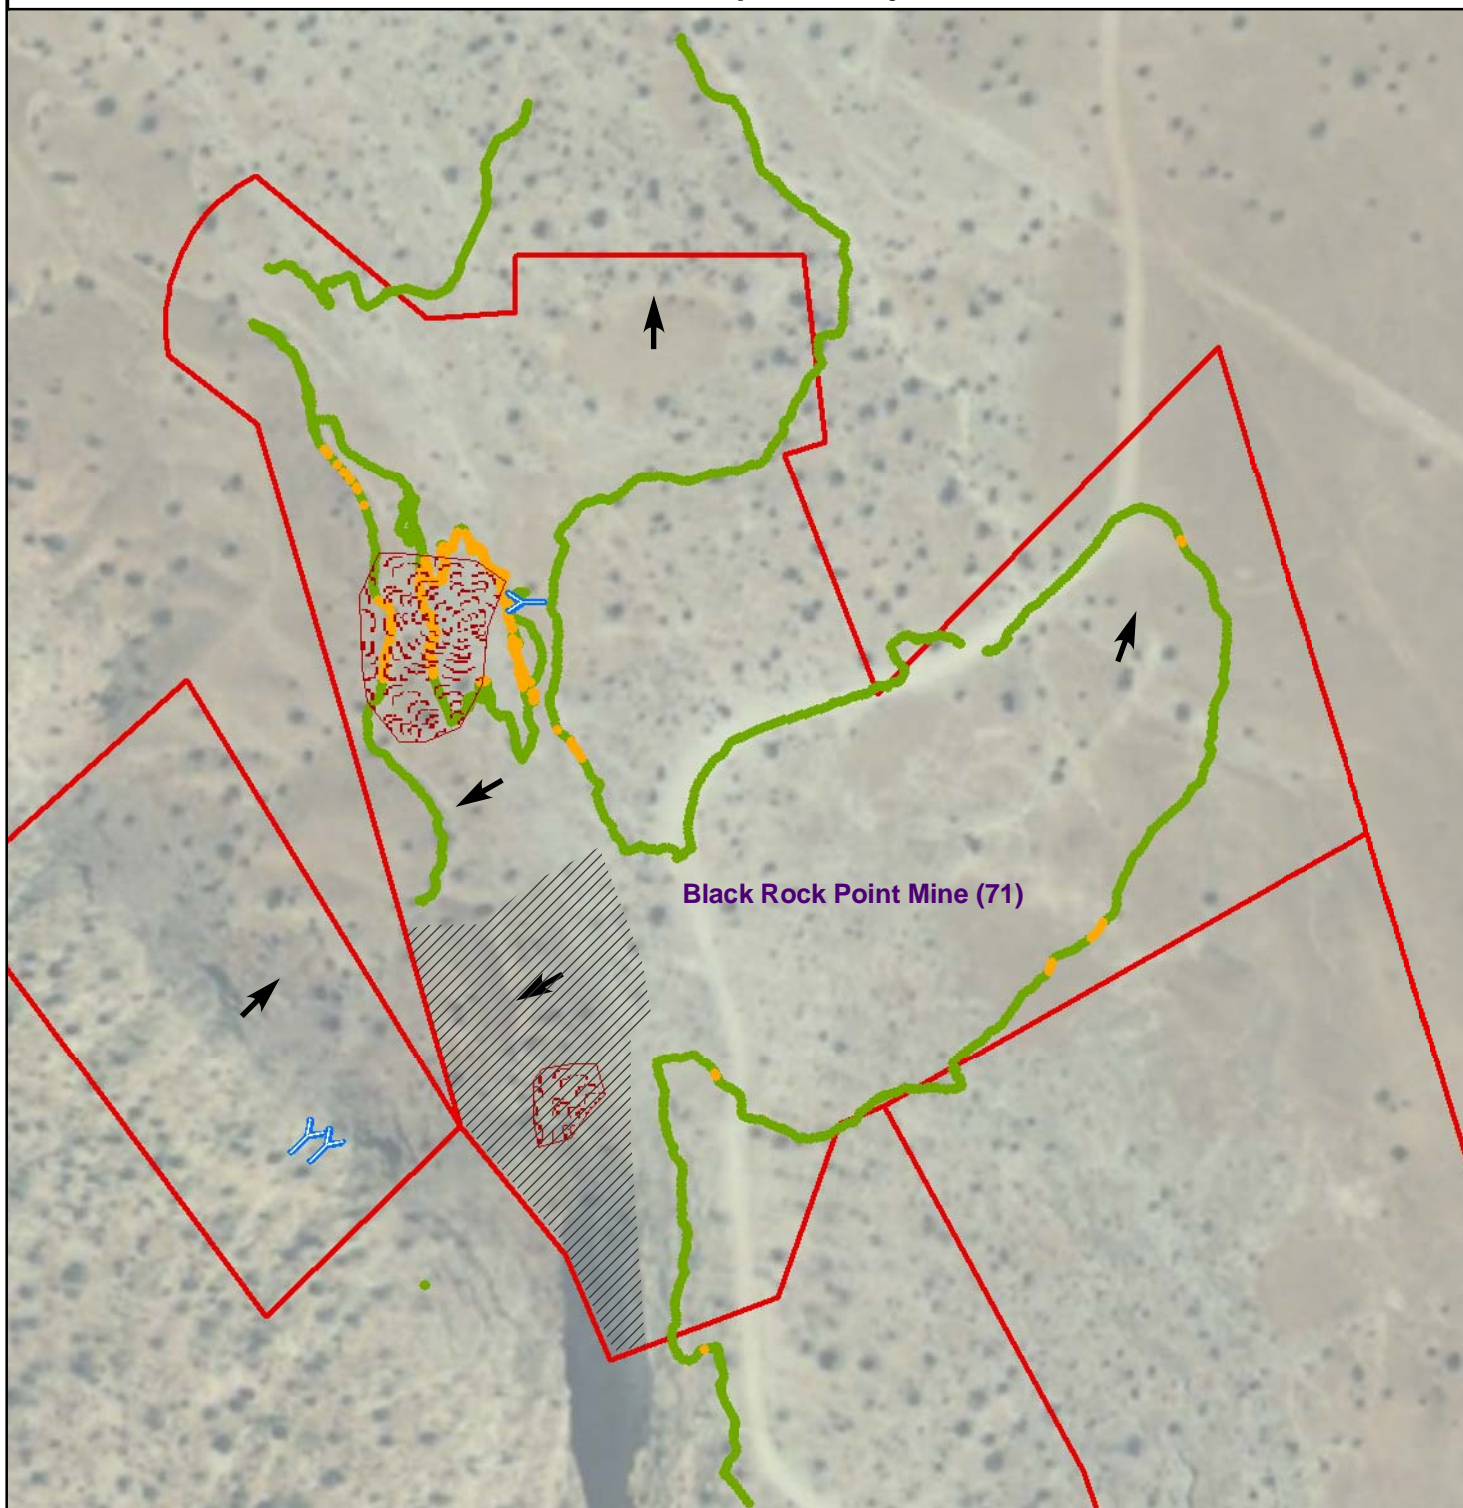
A total of 3,090 gamma radiation measurements were collected from the mine site, ranging from 6,192 cpm to 193,453 cpm. Measurements collected in the vicinity of the waste debris were found at levels up to approximately 190,000 cpm, and near the adit at levels up to approximately 20,000 cpm. The measurements are represented in Figures 1 and 2.

**Figure 1 - Gamma Radiation Measurements, Above Two Times Background
Black Rock Point Mine (71)
Teec Nos Pos Chapter, Navajo Nation**

Gamma survey conducted 06/2010
Measured as counts per minute (cpm)

Average background = 10,180 cpm

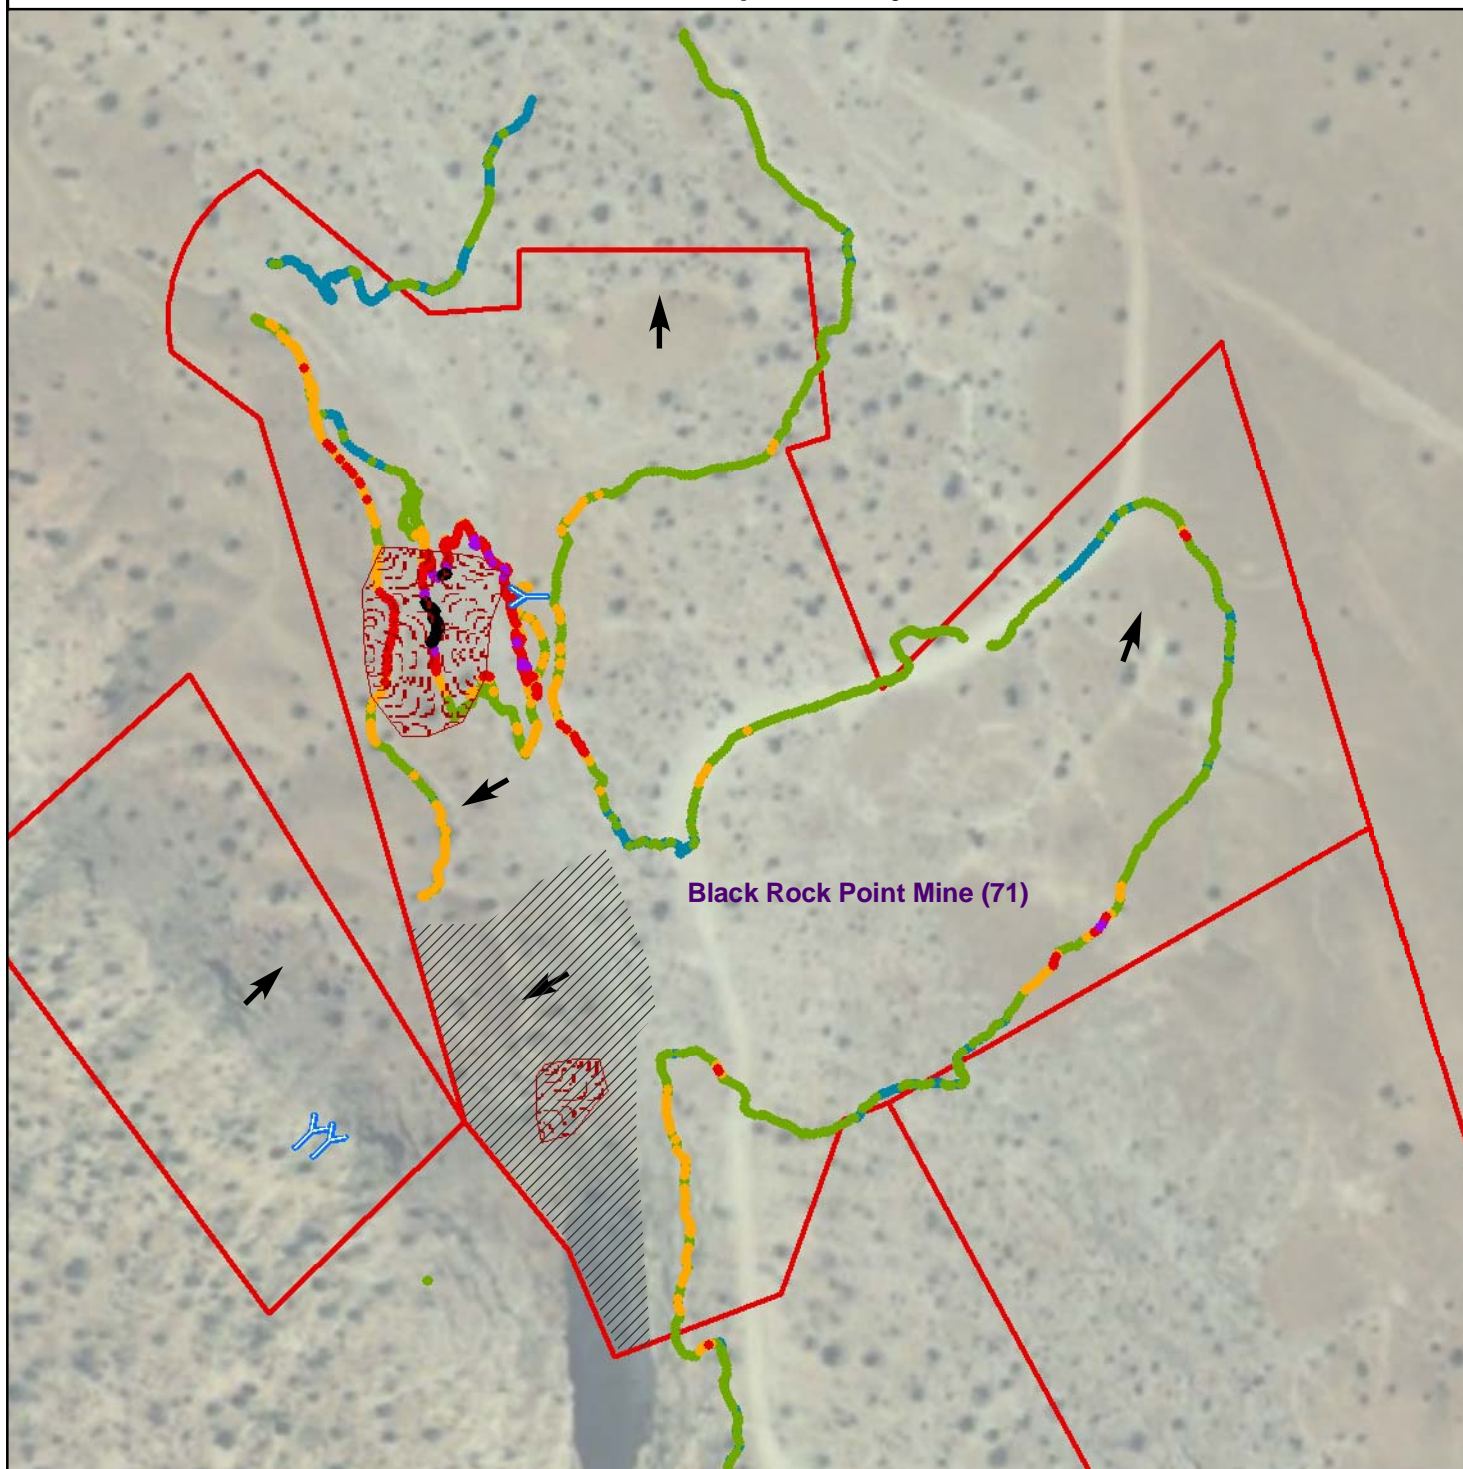
**Figure 2 - Gamma Radiation Measurements
Black Rock Point Mine (71)
Teec Nos Pos Chapter, Navajo Nation**

Gamma survey conducted 06/2010
Measured as counts per minute (cpm)

Average background 10,180 cpm
